## Diagnosis

Clutch System Install Errors,  
Troubleshooting and Driver mis-use  
2019/2020

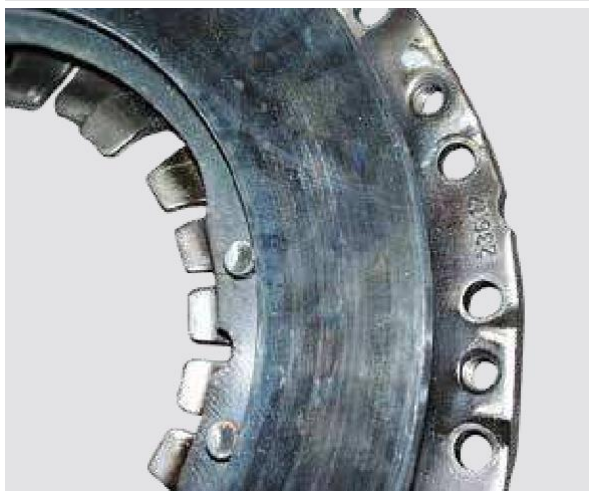
THERMAL LOADING ON THE PRESSURE PLATE IS TOO HIGH

- Oil or grease on the clutch linings
- Play of the release bearing is too low
- Release system is defective
- Operating error, e.g. allowing the clutch to slip for too long

- Rectify the cause
- Replace the clutch kit
- Advise the driver regarding possible operating errors (see page 6)

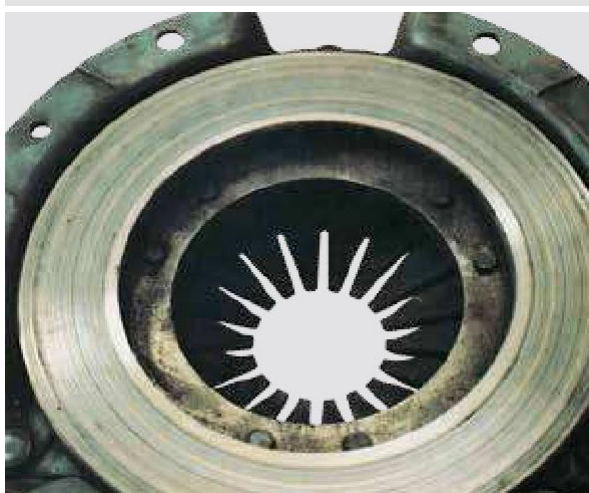
HEAVY SCORING AND TRACES OF OVERHEATING ON THE PRESSURE PLATE

- Clutch has been operated beyond the wearlimit
- Play of the release bearing has been set incorrectly
- Release system is defective
- Operating error

- Rectify the cause
- Replace the clutch kit
- Advise the driver regarding possible operating errors (see page 6)

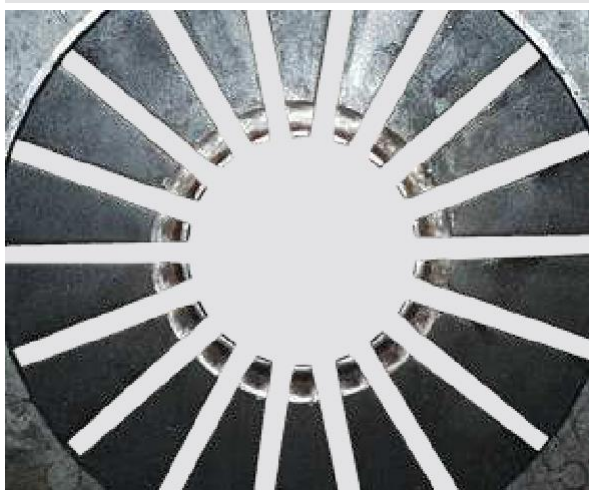
DISK SPRING TIPS HAVE BEEN RUN IN

- Release bearing preload has been set incorrectly
- Release bearing is stiff
- Hydraulic release system is defective

- Clutch slips
- Increased wear on the disk spring tips, to the point that the clutch malfunctions

- Check the release system and rectify damage if necessary
- Replace the clutch, release bearing and guiding sleeve

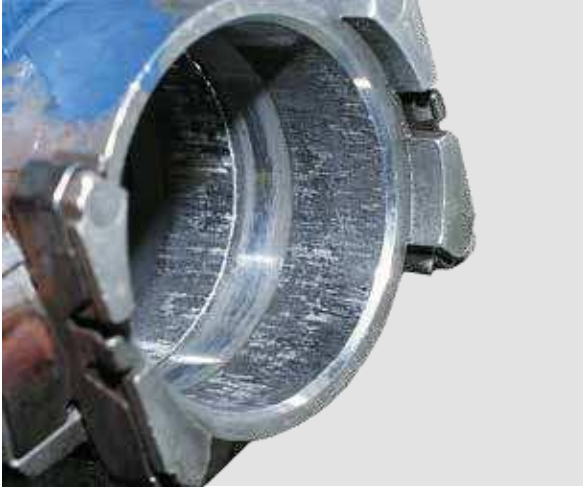
TRACKS IN THE RELEASE BEARING SLEEVE

- Release bearing has been incorrectly or insufficiently greased, or not greased at all
- Sliding bush is worn
- Release bearing is stiff

- Replace the sliding bush and the release bearing
- Grease according to the vehicle manufacturer's specifications if necessary
- Replace the clutch kit

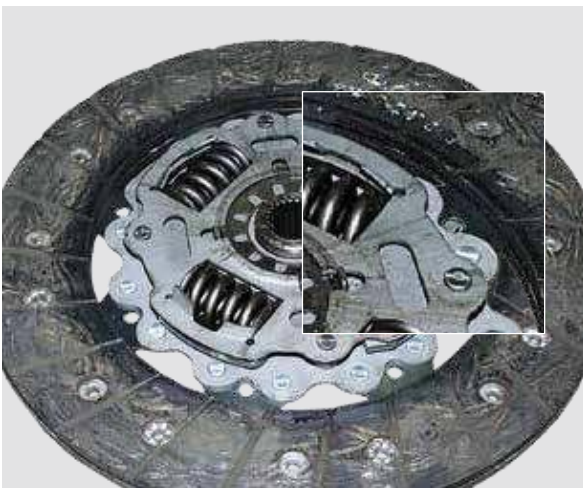
FRICITION LINING ON THE INNER RING IS OILY/ GREASY

- Radial shaft seals or other components in the engine/transmission are leaking
- Hydraulic release system is defective
- Hub profile over-greased

- Lubricant is transferred via the centrifugal force from the hub profile onto the clutch lining, leading to fluctuation of the frictional coefficient, which causes the clutch to grab or slip

- Replace the clutch kit
- Follow the greasing guidelines for the hub
- Check the release system
- Check the engine and transmission for leaks

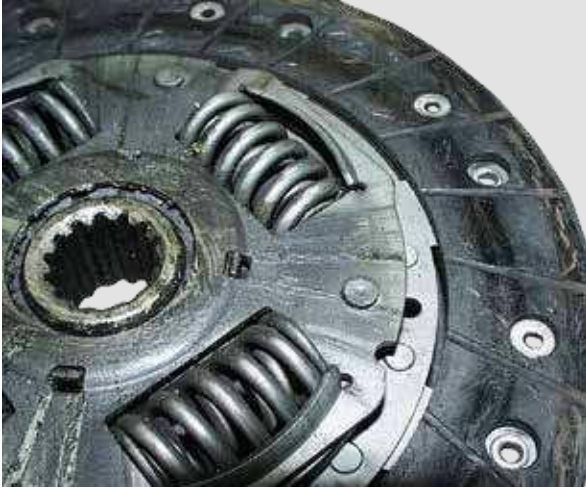
CLUTCH LINING IS OILY

- Radial shaft seals or other components in the engine/transmission are leaking
- Hydraulic release system is defective
- Hub profile over-greased

- Replace the rotary shaft seals
- Clean the clutch cover
- Replace the clutch kit

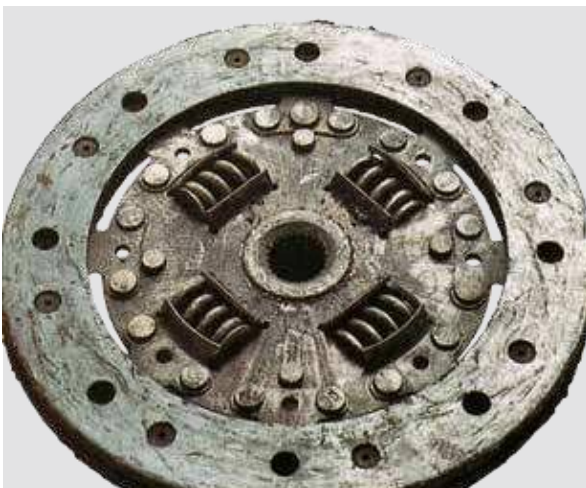
CLUTCH LININGS ARE COVERED IN EXCESS GREASE

- Hub of the clutch disk has not been greased correctly
- Too much lubricant has been used

- Clean the clutch cover
- Clean the transmission inputshaft
- Replace the clutch kit
- Grease the hub correctly

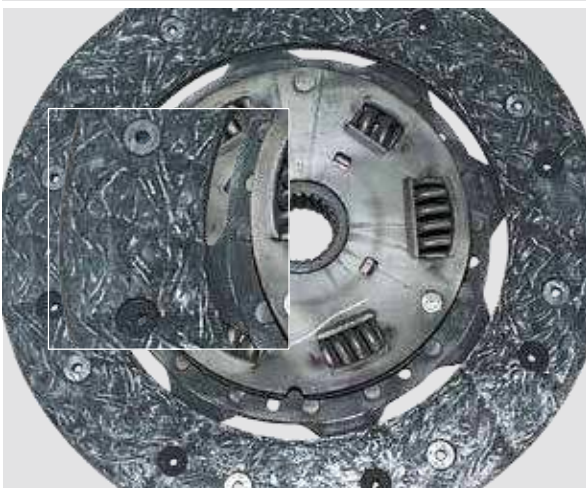
CLUTCH LINING IS WORN DOWN TO THE RIVETS

- Normal wear
- Vehicle was still driven despite the clutch slipping
- Driving errors (in the event of a premature malfunction)
- Incorrect clutch
- Release system is defective

- Replace the clutch kit
- Check the release system and repair if necessary
- Advise the driver regarding possible operating errors (see page 6)

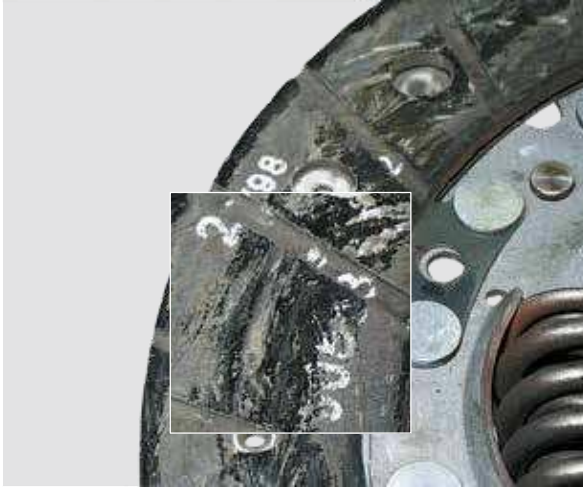
LINING SCORED ON THE FLYWHEEL SIDE

- Wear on the friction surface of the flywheel was not noticed when the clutch was replaced
- Rigid flywheel has not been reworked or the DMF has not been replaced

- Replace the clutch kit
- Rework the friction surface or replace the flywheel (in the case of a rigid flywheel)
- Do not rework the friction surface of the DMF! If worn, replace the component

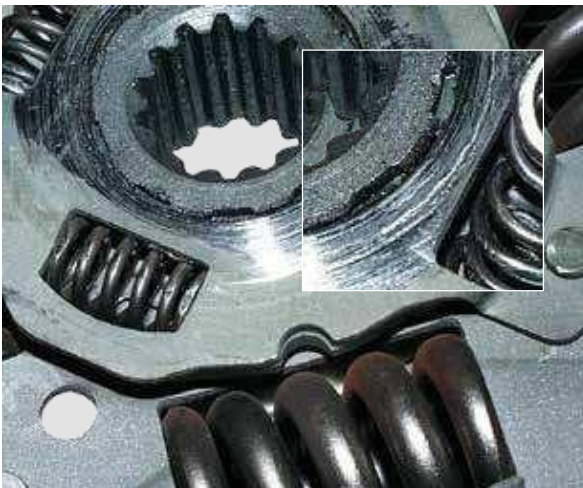
CONTACT TRACKS ON THE HUB OF THE CLUTCH DISK

- Assembly error (installation direction of the clutch disk is incorrect)
- Incorrect clutch disk has been installed

- Replace the clutch kit
- Note the correct installation position of the clutch disk

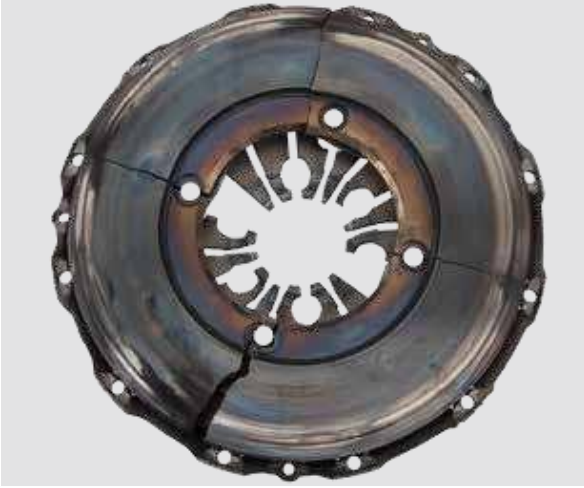
PRESSURE PLATE HAS OVERHEATED/BROKEN

- Damage caused by force and operating errors
- Driving with an excessive load

- Replace the clutch kit
- Advise the driver regarding operating errors

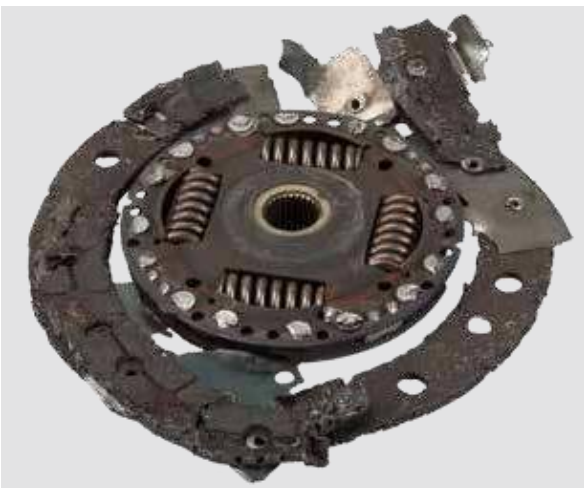
CLUTCH DISK HAS BURST

- Damage caused by force and operating errors
- Speed of the clutch disk was higher than the burst speed of the lining. This condition occurs when the speed of the vehicle exceeds the maximum permissible speed of the gear when the gear is engaged and the clutch is actuated continuously

- Replace the clutch kit
- Advise the driver regarding operating errors

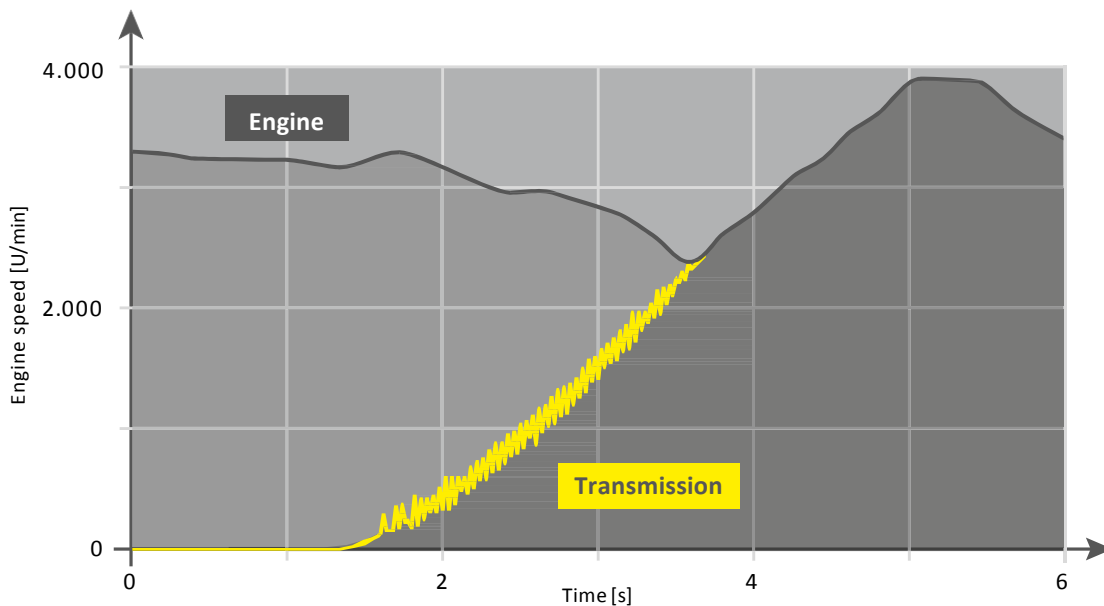
#### Clutch grabs

When the clutch grabs during a start-up procedure, vibrations occur in the form of periodic fluctuations in the rpm, which generally last until the two speeds have reached the same level. These deviations are perceived during every start-up procedure as irritating vehicle vibrations.

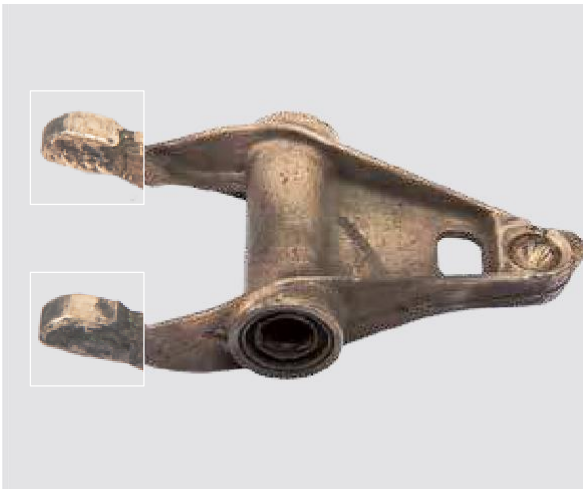
RELEASE FORK TIPS ARE WORN  
(PULL-TYPE CLUTCH)

- Normal wear
- Release fork was not replaced when the clutch was replaced despite wear

- Replace the release fork each time a clutch is replaced

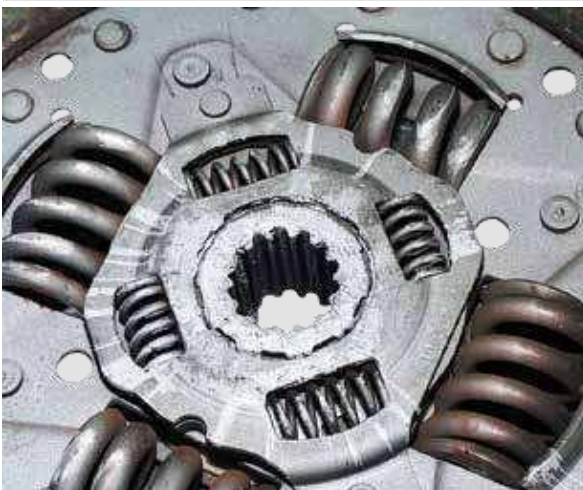
HUB PROFILE HAS BEEN INCORRECTLY GREASED

- Unsuitable or excessive grease has been applied

- Lubricant is transferred via the centrifugal force to the friction surfaces of the clutch, leading to fluctuation of the frictional coefficient, which causes the clutch to grab

- Observe the specifications of the vehicle manufacturer for greasing the hub when performing a clutch replacement. Use the instructions on page 40 as an alternative if there are no documents available from the vehicle manufacturer

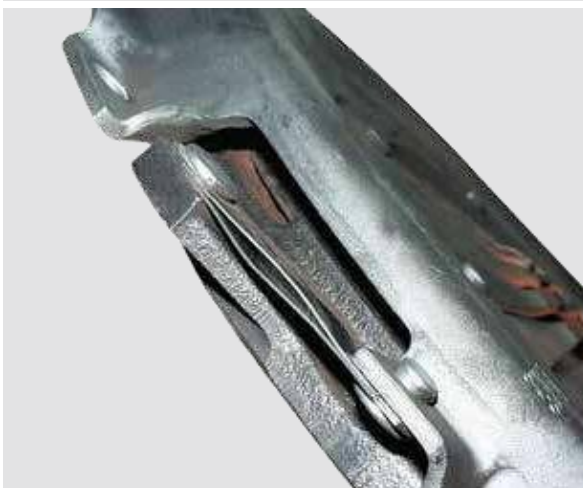
TANGENTIAL LEAF SPRING IS BENT

- Play within the powertrain (e.g. due to a dislodged disk joint or flex disk)
- Reverse torque transmission in the clutch (towing in first or second gear, shifting error, load reversal caused by the conveyor belt in a car wash when the vehicle is in first gear)

- Uneven lift of the pressure plate causes the clutch to grab

- Replace the clutch kit
- Check the powertrain and eliminate play if necessary
- Advise the driver regarding possible operating errors

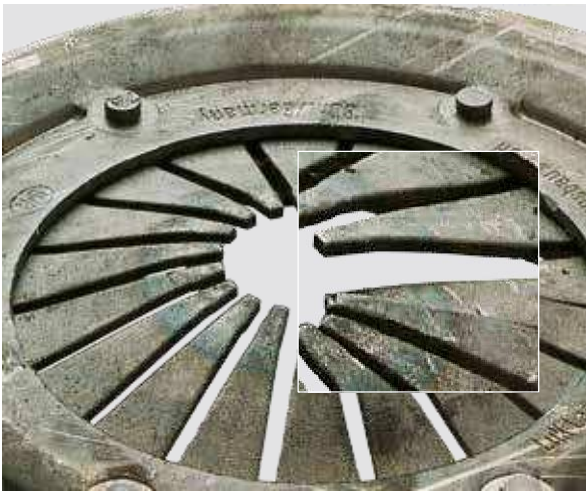
DISK SPRING TIPS ARE BENT

- Assembly error: Disk spring tips have been bent during installation of the transmission

- Replace the clutch kit
- Remove and install the transmission in accordance with the vehicle manufacturer's instructions

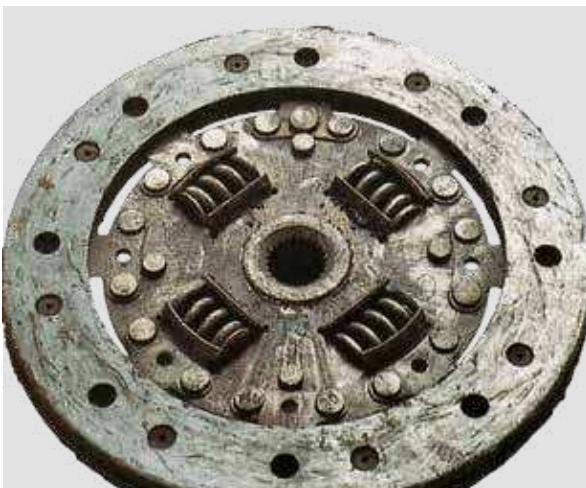
CLUTCH LINING IS OILY

- Assembly error (incorrect and/or excessive lubricant applied)
- Engine or transmission is leaking

- Replace the clutch kit
- Eliminate leaks from the engine and transmission
- Note the specifications for greasing the clutch hub

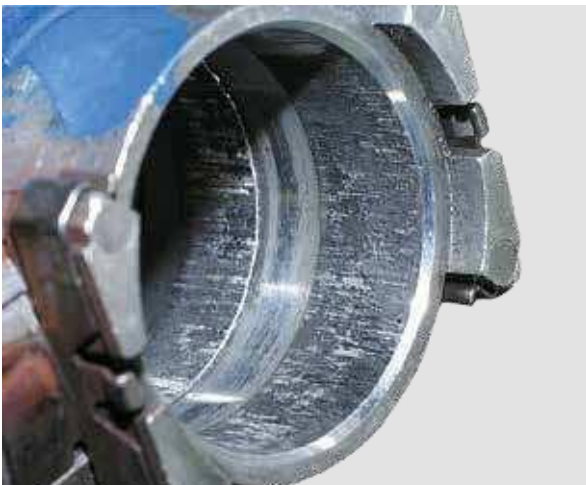
RELEASE BEARING IS STIFF,  
SIGNS OF WEAR ARE VISIBLE

- Incorrectly or insufficiently greased
- Sliding bush is worn and was not replaced when the clutch was replaced

- Replace the clutch kit, release bearing and sliding bush
- Note the specifications for greasing the release bearing and the sliding bush

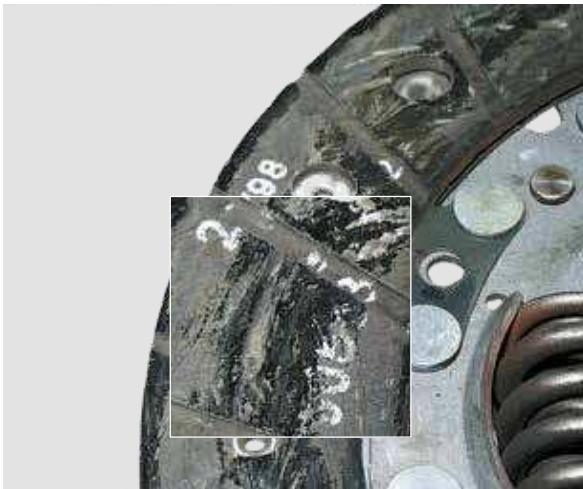
LINING SCORED ON THE FLYWHEEL SIDE

- Wear on the friction surface of the flywheel was not noticed when the clutch was replaced
- Rigid flywheel has not been reworked or the DMF has not been replaced

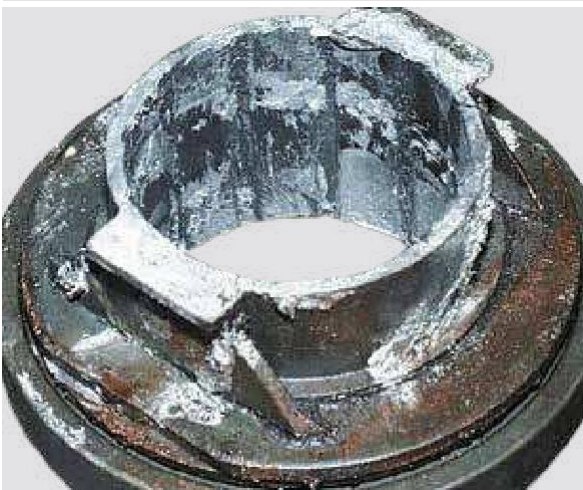
RELEASE BEARING HAS BEEN INCORRECTLY GREASED

- Release bearing or sliding bush have been greased using an unsuitable lubricant

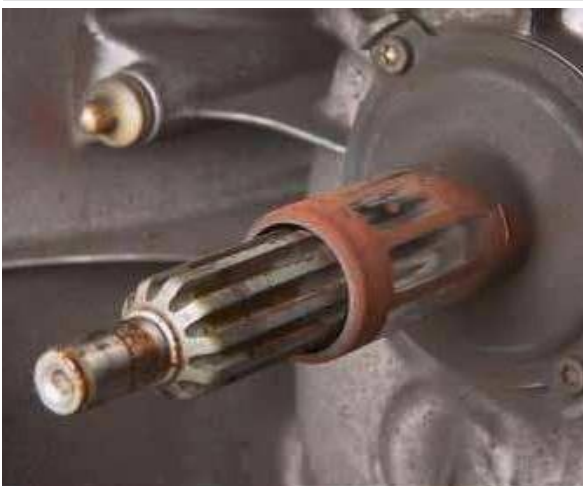
GUIDING SLEEVE HAS BEEN RUN IN

- Normal wear
- Sliding bush is worn and was not replaced when the clutch was replaced

- Replace the guiding sleeve
- Replace the clutch kit
- Follow the greasing guidelines

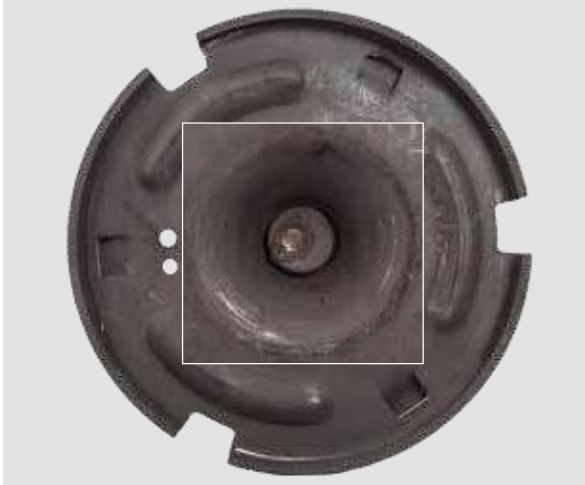
#### OFF-CENTER CONTACT TRACK IN THE RELEASE SPRING (VW CLUTCHSYSTEM)

- Release bearing on the push rod is deformed
- Guide bush on the push rod is worn

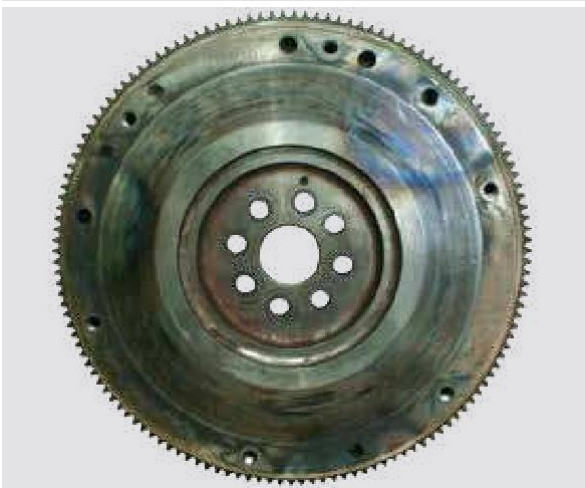
#### FRICTION SURFACE ON THE FLYWHEEL IS WORN

- High temperatures, e.g. due to operating errors or a defect in the releasesystem
- Friction surface on the flywheel is worn (rigid design) and was not reworked when the clutch was replaced
- DMF is worn and has not been replaced

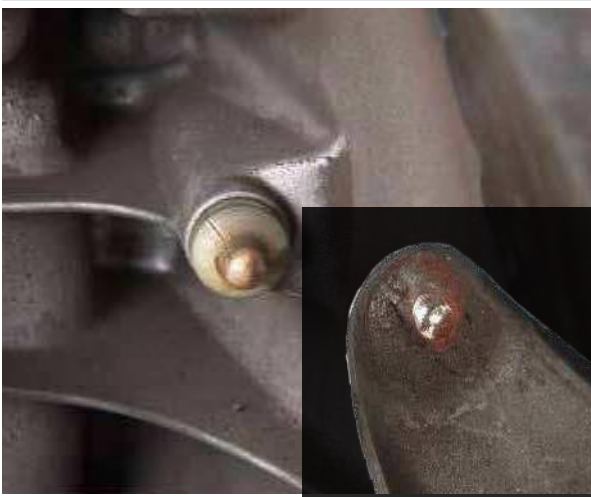
#### RELEASE FORK AND/OR BALL PIN IS WORN

- Normal wear

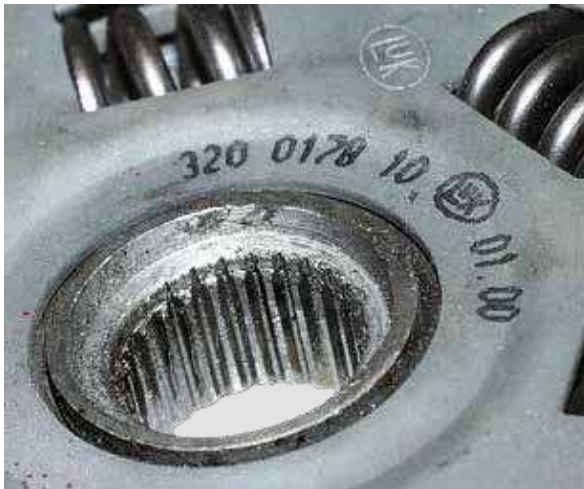
HUB PROFILE IS DAMAGED

- Transmission input shaft has been forced into the hub
- Clutch disk was not centered during installation
- Incorrect clutch has been installed

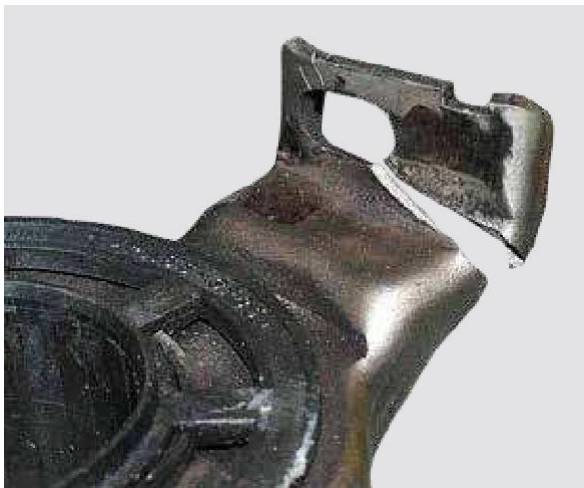
RELEASE FORK MOUNT ON THE RELEASE BEARING IS BROKEN

- Fork and release bearing not installed correctly
- Incorrect release bearing installed

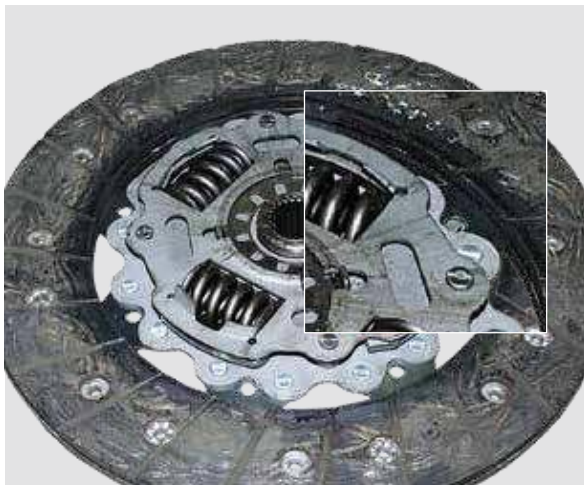
FRICTION LINING ON THE INNER RING IS OILY/ GREASY

- Radial shaft seals or other components in the engine/transmission are leaking
- Hydraulic release system is defective
- Hub profile over-greased

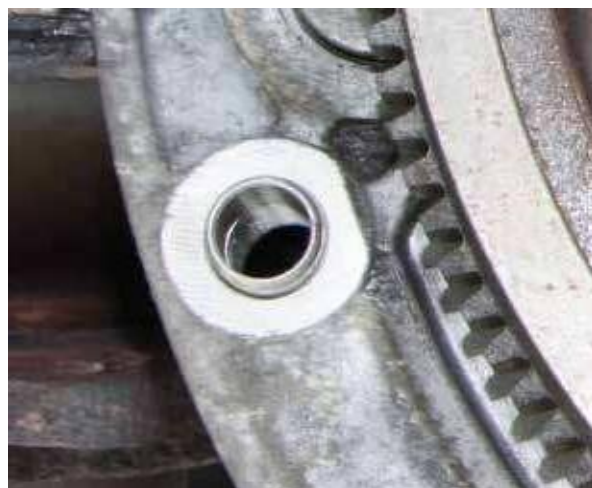
If the centering sleeve is missing or deformed, this can cause problems when disengaging the clutch.

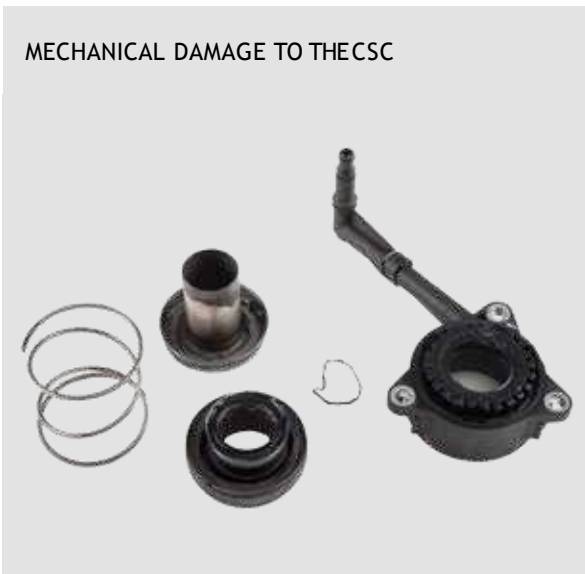
#### MECHANICAL DAMAGE TO THE CSC

- Sliding bush of the CSC has rotated and worked loose from the housing due to the axial clearance of the transmission input shaft being too high

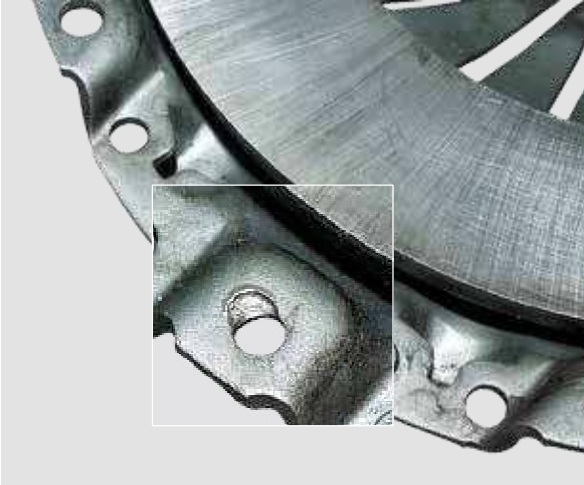
#### CLUTCH COVER IS DEFORMED

- Centering pin in the flywheel was not accounted for when installing the pressure plate

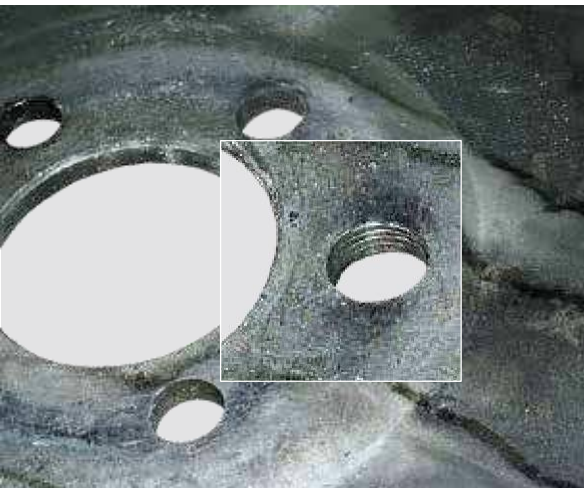
#### THREAD IN THE SCREW HOLES IS WORN, TANGENTIAL LEAF SPRING IS BROKEN (VW)

- No securing agent used to fix the clutch screws in place
- Reinforcing panel not installed between the clutch screws and the clutch cover
- Screws have been tightened to the incorrect torque

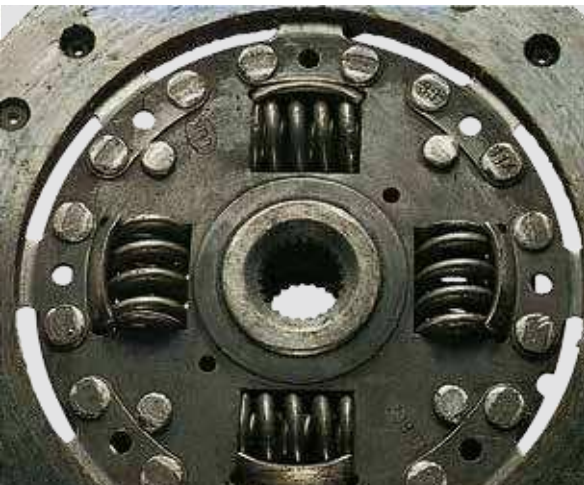
#### CONTACT TRACKS ON THE RIVET HEADS OF THE SEGMENT RIVETING (VW)

- Snap ring on the pressure plate has been installed incorrectly
- Unsuitable snap ring has been installed

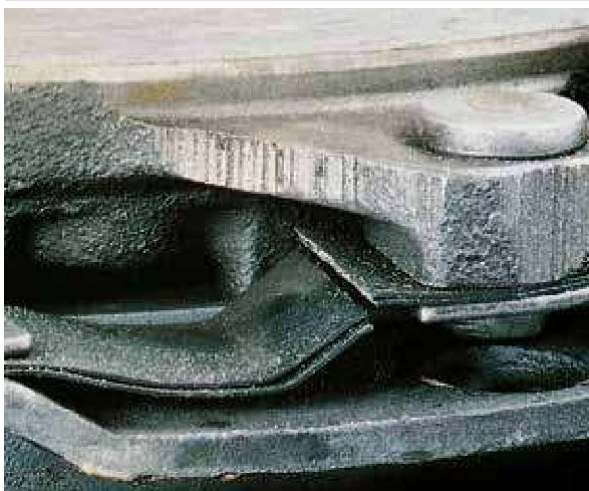
TANGENTIAL LEAF SPRING IS BROKEN

- Play within the powertrain, e.g. a dislodged flex disk
- Operating errors, e.g. towing in first or second gear, shifting error
- Incorrect clutch has been installed

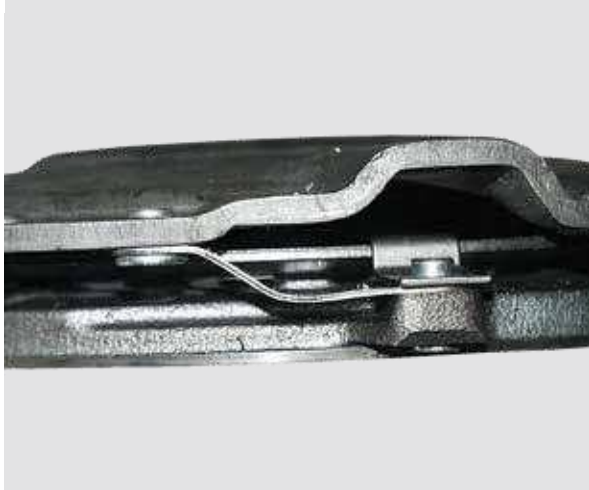
TANGENTIAL LEAF SPRING IS BENT

- Play within the powertrain, e.g. a dislodged flex disk
- Operating errors, e.g. towing in first or second gear, shifting error
- Improper bearing arrangement for the clutch
- Clutch dropped before or during assembly
- Incorrect detent when screwing on the clutch

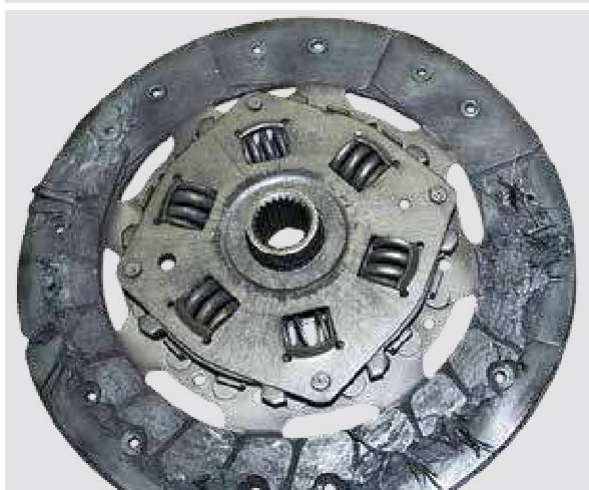
LINING IS BURNT OR HAS WORKED LOOSE

- Defective rotary shaft seal on the engine/gearbox, causing the lining to become oily
- Release system is stiff or defective
- Depth dimension was not considered when reworking the flywheel (rigid design) or the mounting surface of the clutch has not been machined

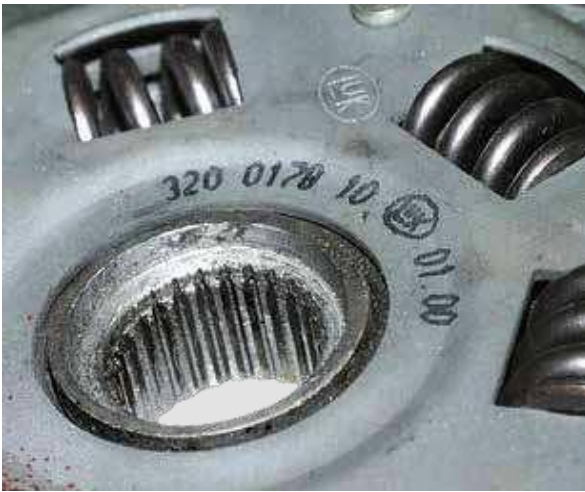
HUB PROFILE IS DAMAGED

- Transmission input shaft has been forced into the hub
- Clutch disk was not centered during installation
- Incorrect clutch has been installed

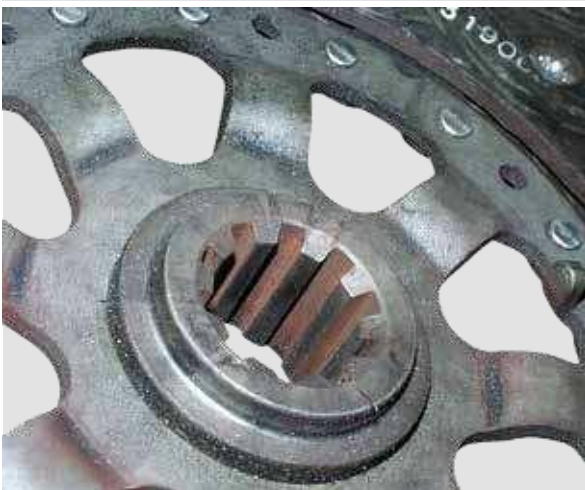
FRETTING CORROSION (RUST FILM) ON THE HUB PROFILE

- Transmission input shaft or hub profile not greased at all or greased using an unsuitable lubricant

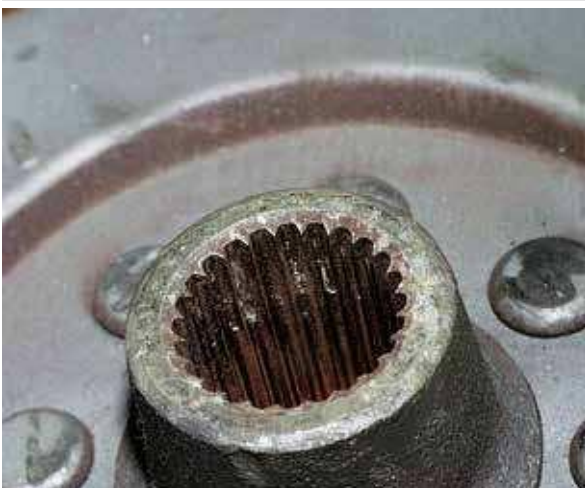
HUB PROFILE IS DEFORMED, TAPERED GEARING PROFILE

- Pilot bearing is defective
- Angular displacement between the engine and the transmission
- No centering sleeve or the centering sleeve is damaged

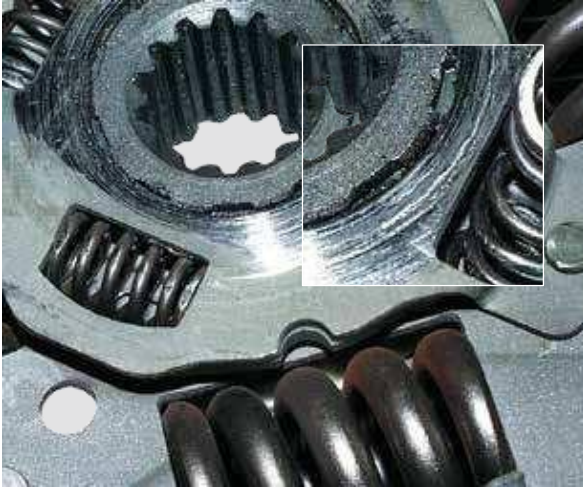
CONTACT TRACKS ON THE FIRST STAGE DAMPER OF THE CLUTCH DISK

- Installation position for the clutch disk is incorrect
- Incorrect clutch disk has been installed

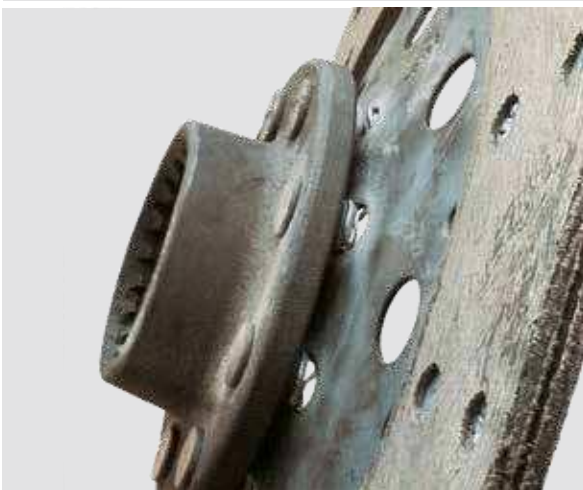
CLUTCH DISK HAS BECOME SAUCER-SHAPED

- Clutch disk has not been centered and has been deformed by subsequent installation of the transmission

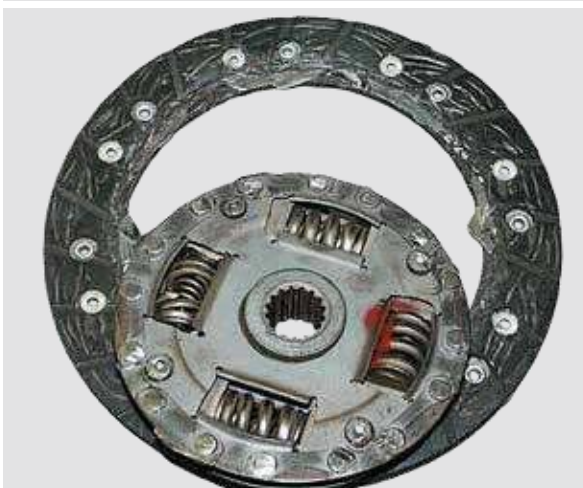
DISC ASSEMBLY IS BROKEN

- Pilot bearing is defective or missing
- Angular or parallel displacement between the engine and transmission
- Transmission has been lowered during installation

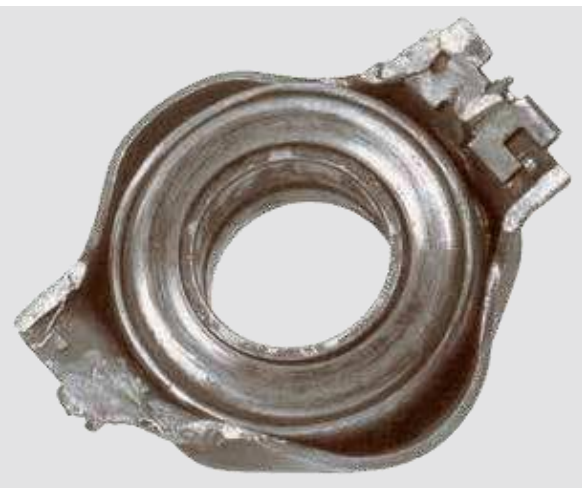
HOUSING OF THE RELEASE BEARING IS DEFORMED

- Release bearing is blocked on the guiding sleeve
- Bearing arrangement on the release shaft is worn

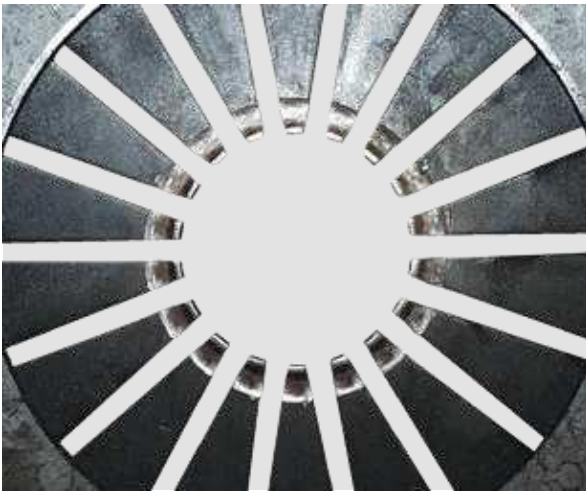
DISK SPRING TIPS HAVE BEEN RUN IN

- Default setting of the release fork is incorrect (Opel)
- Preload on the release bearing is too low

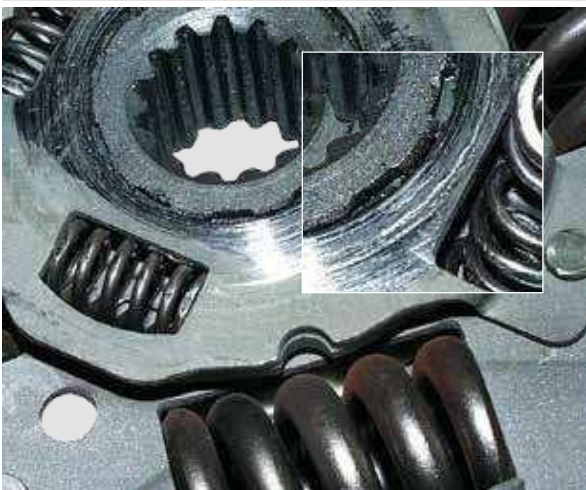
CONTACT TRACKS ON THE FIRST STAGE DAMPER

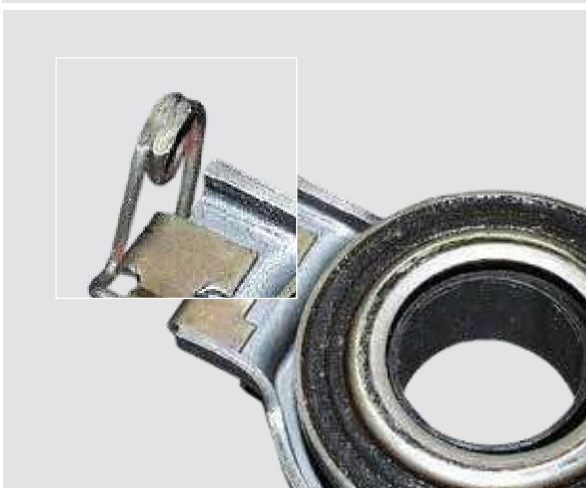
CONTACT TRACKS ON THE FORMED SPRING

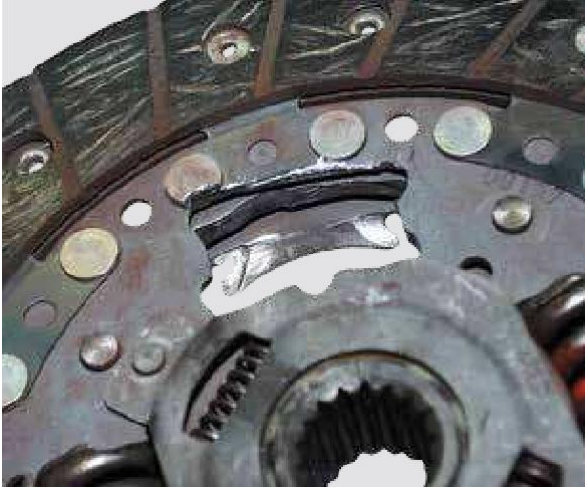
SPRING WINDOW IS WORN

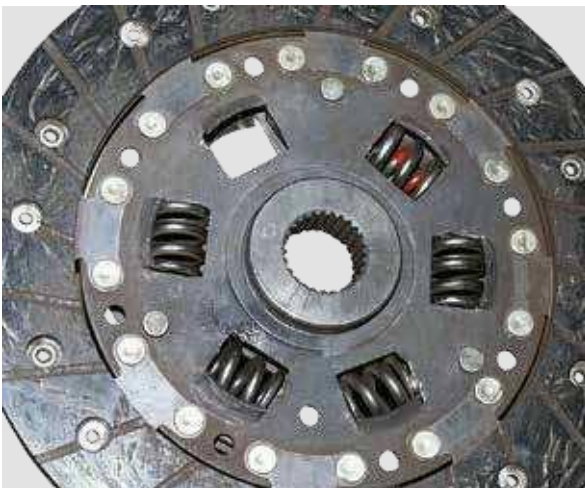
TORSION SPRING IS BROKEN

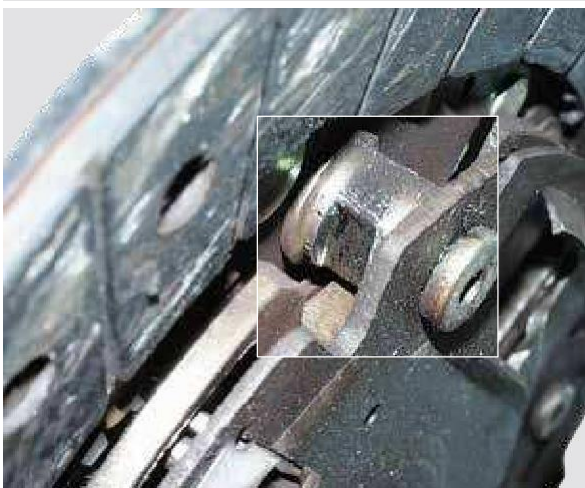
STOP PIN IN THE TORSIONAL DAMPER IS WORN

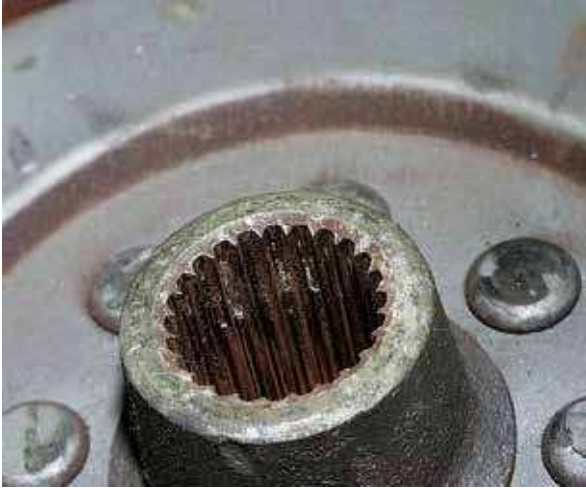
HUB PROFILE IS DEFORMED, TAPERED GEARING PROFILE TORSIONAL DAMPER IS DESTROYED

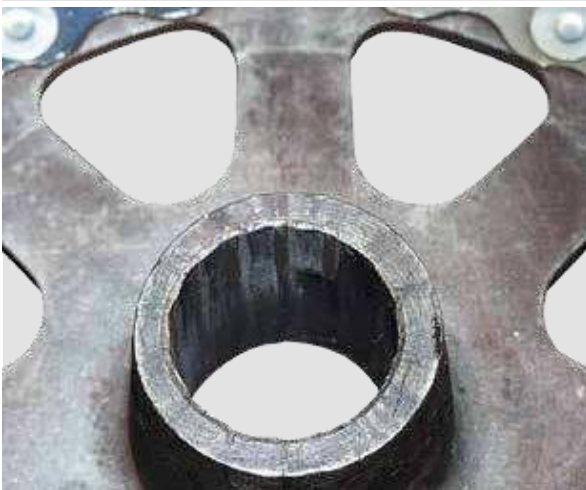
HUB PROFILE IS COMPLETELY MISSING

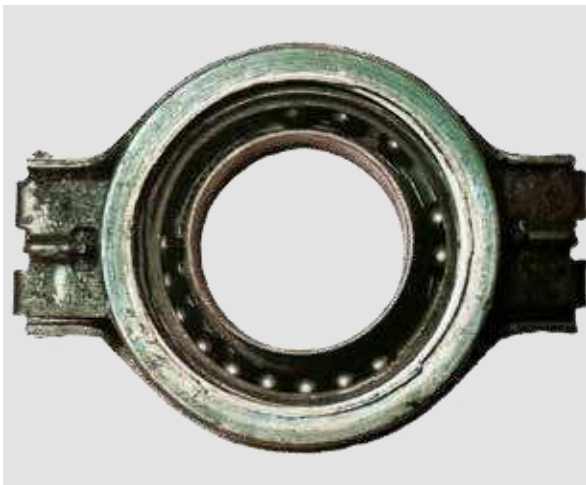
CONTACT BUSHING AND BALL BEARING ARE DESTROYED

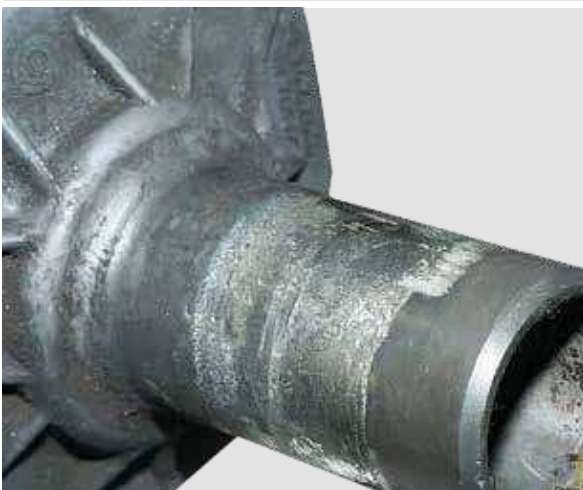
SIGNS OF WEAR VISIBLE ON THE GUIDING SLEEVE

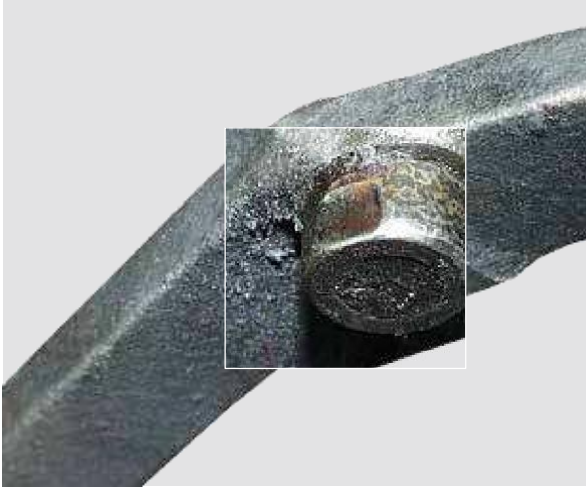
RELEASE BEARING SEATING ON THE RELEASE FORK HAS BEEN RUN IN

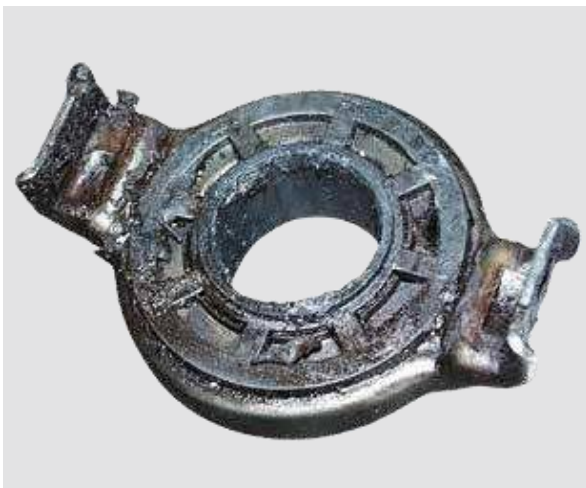
RELEASE BEARING SEATING IS WORN

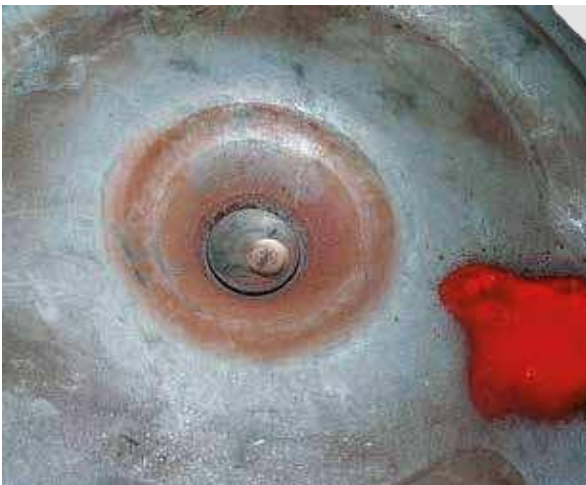
OFF-CENTER CONTACT TRACK IN THE RELEASE SPRING (VW CLUTCHSYSTEM)

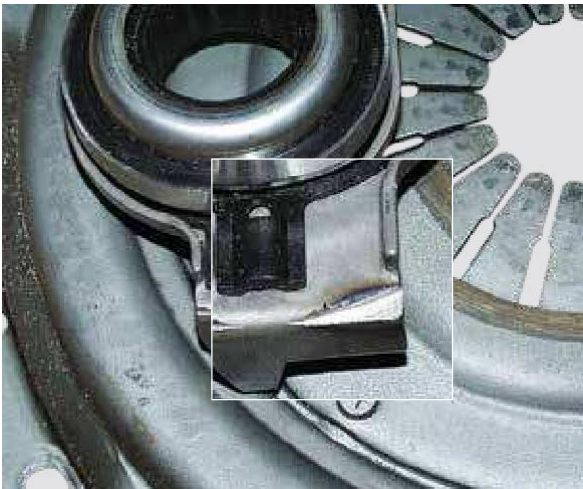
CONTACT TRACKS ON THE CLUTCH COVER AND  
RELEASE BEARING

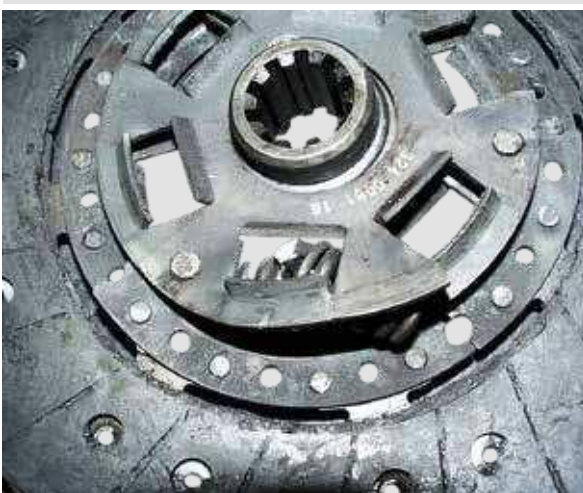
TORSIONAL DAMPER IS BROKEN

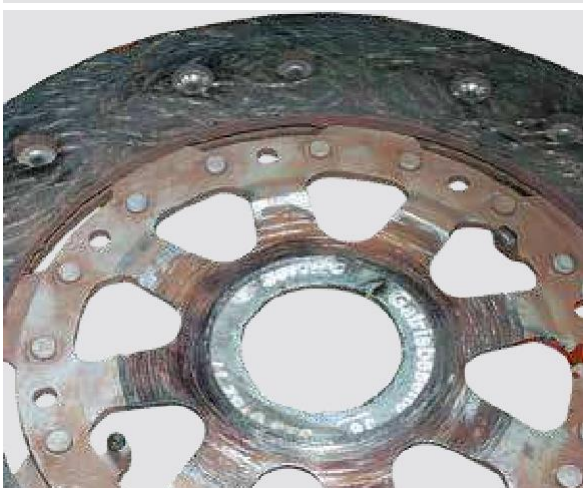
HUB OF THE CLUTCH DISK IS BROKEN

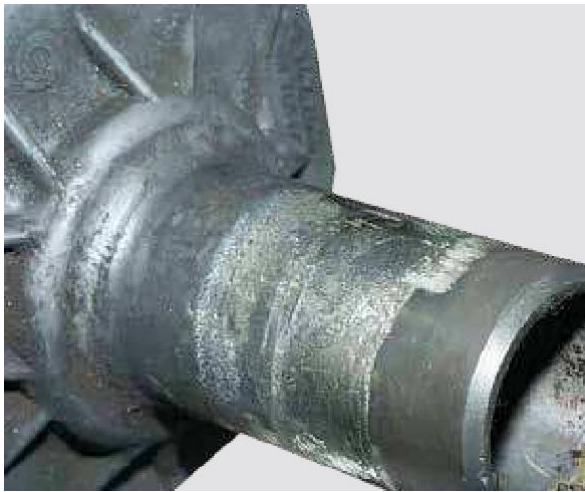
### CONTACT TRACKS ON THE GUIDING SLEEVE

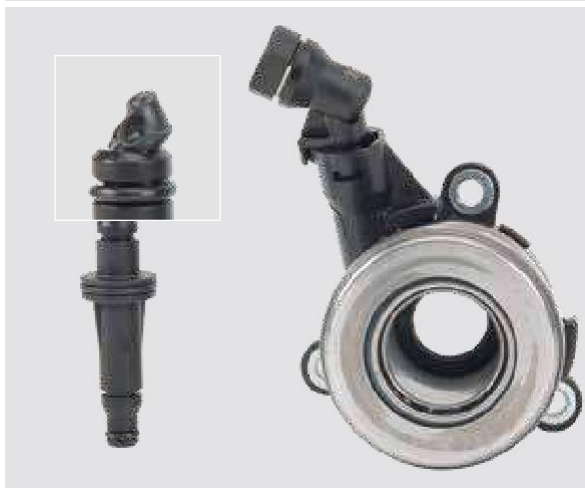
### CSC BURSTS DIRECTLY AFTER INSTALLATION

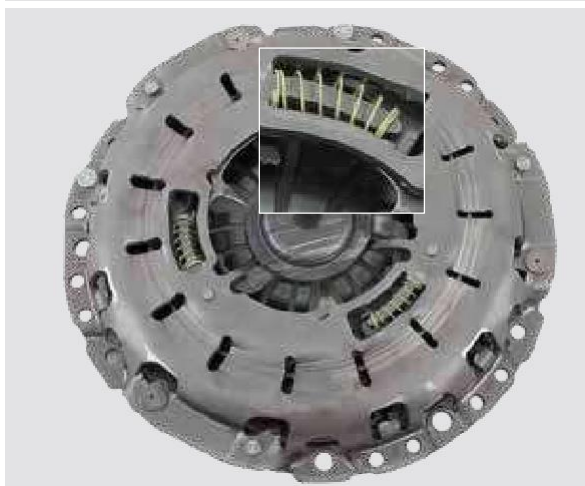
### NEW SAC IS ALREADY COMPLETELY ADJUSTED

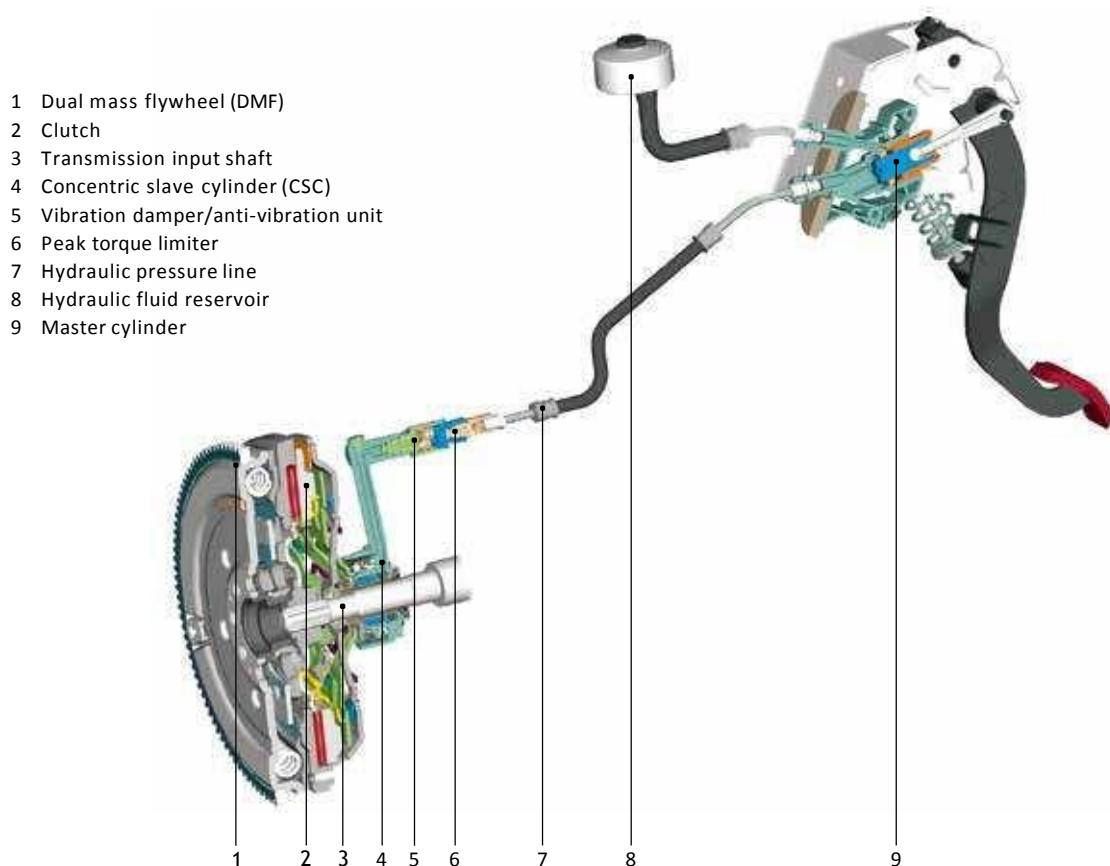
Design of a fully hydraulic clutch system
