## Diagnosis

Clutch System Install Errors,  
Troubleshooting and Driver mis-use  
2019/2020

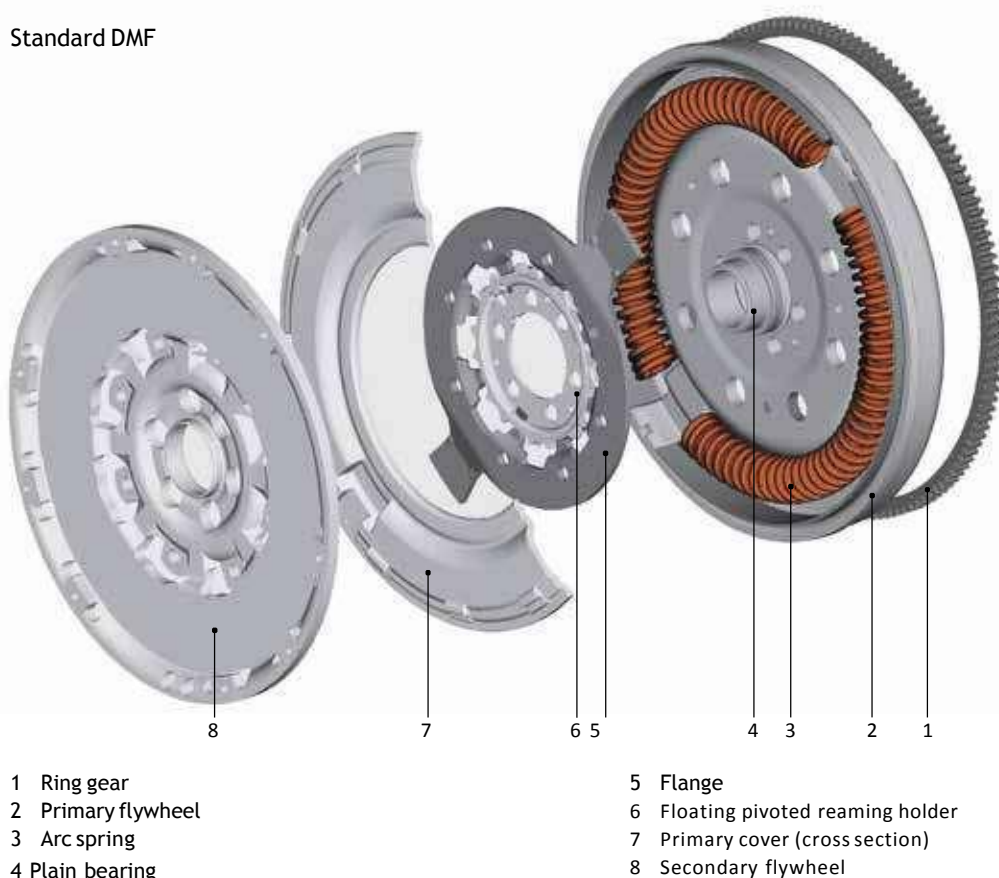
Standard DMF
